Quality Assurance and Source Inspection

Contract #: 04-0120F4Cty: SF/ALA Rte: 80 PM: 13.2/13.9File #: 1.28**WELDING INSPECTION REPORT****Resident Engineer:** Casey, William**Address:** 333 Burma Road**City:** Oakland, CA 94607**Report No:** WIR-028303**Date Inspected:** 29-Aug-2012**Project Name:** SAS Superstructure**OSM Arrival Time:** 700**Prime Contractor:** American Bridge/Fluor Enterprises, a JV**OSM Departure Time:** 1930**Contractor:** American Bridge/Fluor Enterprises, a JV**Location:** Job site**CWI Name:** Salvador Merino**CWI Present:** Yes No**Inspected CWI report:** Yes No N/A**Rod Oven in Use:** Yes No N/A**Electrode to specification:** Yes No N/A**Weld Procedures Followed:** Yes No N/A**Qualified Welders:** Yes No N/A**Verified Joint Fit-up:** Yes No N/A**Approved Drawings:** Yes No N/A**Approved WPS:** Yes No N/A**Delayed / Cancelled:** Yes No N/A**Bridge No:** 34-0006**Component:** OBG**Summary of Items Observed:**

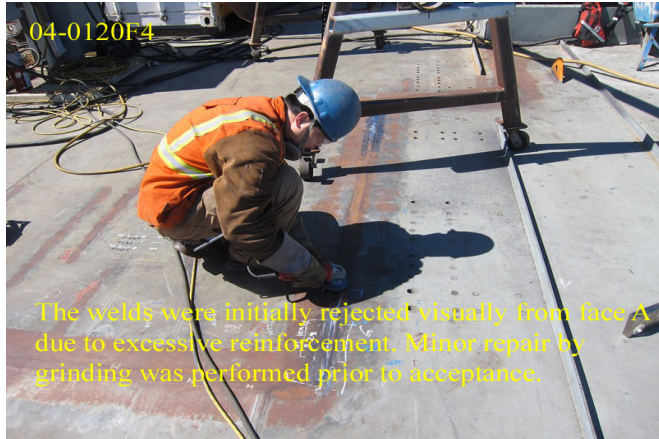
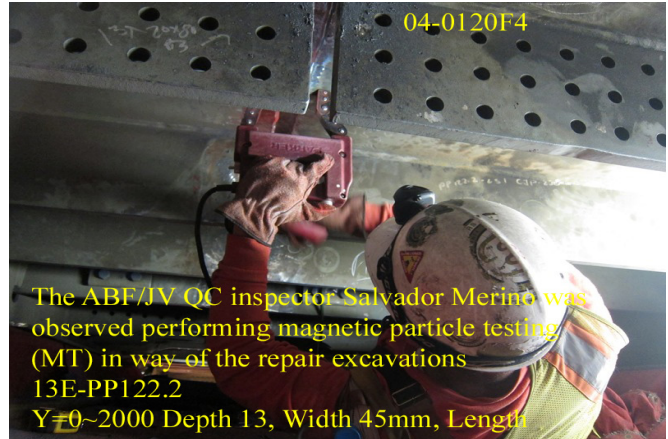
The QAI performed a minimum of 30% verification of this weld. A total of one rejectable indication was observed at the time of inspection. The Rejectable indication was confirmed by ABF QC inspector Harry Scharein during this shift.

The QAI noted and periodically observed ABF welder Eric Sparks #3040 performing Shielded Metal Arc Welding (SMAW) in the 3G position utilizing the Caltrans approved Welding Procedure Specifications ABF-WPS-D1. 5-1004-Repair. The repairs are located on the edge plate field splice between lift 13E/14E. The weld is designated

A minimum of 15% verification was performed from face A/B. The QAI observed no rejectable indications at the time of testing; however the welds were initially rejected visually from face A due to excessive reinforcement. Minor repair by grinding was performed prior to acceptance.

The QAI then noted and periodically observed ABF welder Richard Garcia #5892 performing Flux Cored Arc Welding (SMAW) in the 4G position utilizing the Caltrans approved Welding Procedure Specifications ABF-WPS-D1.5-3110-4. The repairs are located on deck panel drop-in splice transverse weld designated as 13E-PP122. The weld and surrounding area was brought to a temperature by the use of induction heaters and the Quality Control (QC) inspector Fred Michaels was observed monitoring the welding parameters at the beginning of welding. After review of the request for weld repair document RWR201208-105, the QAI confirmed that the ABF QC disregarded the approved document and performed critical weld repairs with a welding procedure not specified in the approved document. The repair welding was performed on approximately two meters of the of the transverse deck splice. The weld connection is designated on the contract drawings as a Seismic Performance Critical Member (SPCM). The QA task leader was notified in writing of the non-compliant issue for further discussion with the Caltrans Structural Materials Representative (SMR) and ABF Management.
